**FOCUSED SITE INSPECTION PRIORITIZATION
SITE EVALUATION REPORT**

**MARBLE CLIFF QUARRIES DUMP
3101 TRABUE ROAD
COLUMBUS, OHIO**

OHD 980 510 226

Date Prepared	:	September 13, 1994
EPA Region	:	5
Contract No.	:	68-W8-0084
Work Assignment No.	:	29-5JZZ
PRC Project No.	:	030-003526
Prepared by	:	PRC Environmental Management, Inc. (John Grabs)
PRC Project Manager	:	Julie Kaiser
Telephone No.	:	(703) 556-2585
EPA Work Assignment Manager	:	Jeanne Griffin
Telephone No.	:	(312) 886-3007

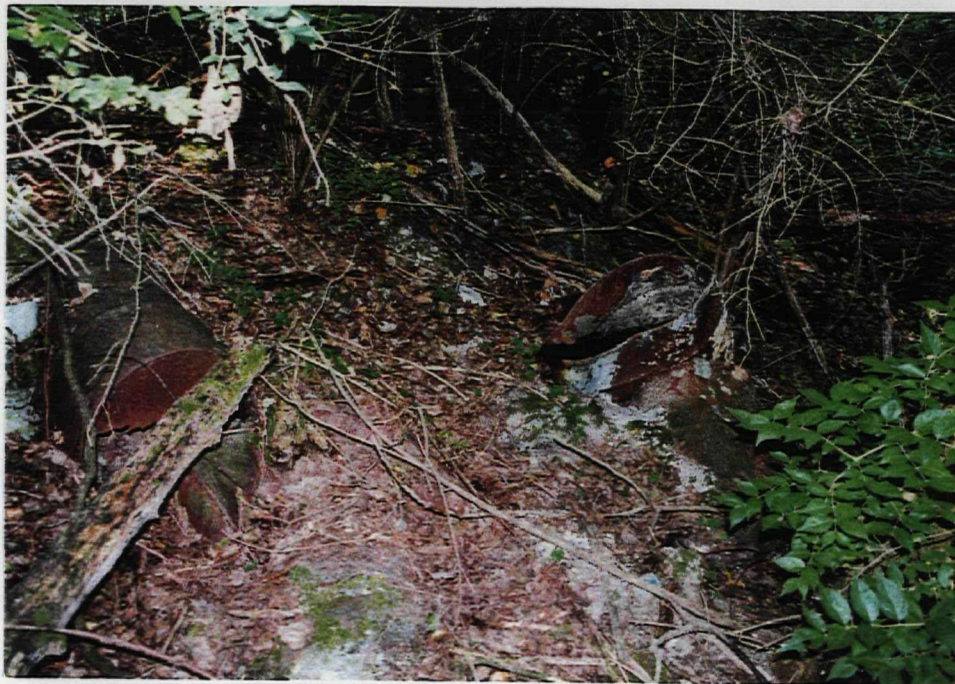
Photograph No. 1
 Orientation: West
 Description: Area of exposed waste showing rusted drums

Location: Exposed waste area
 Date: July 28, 1994

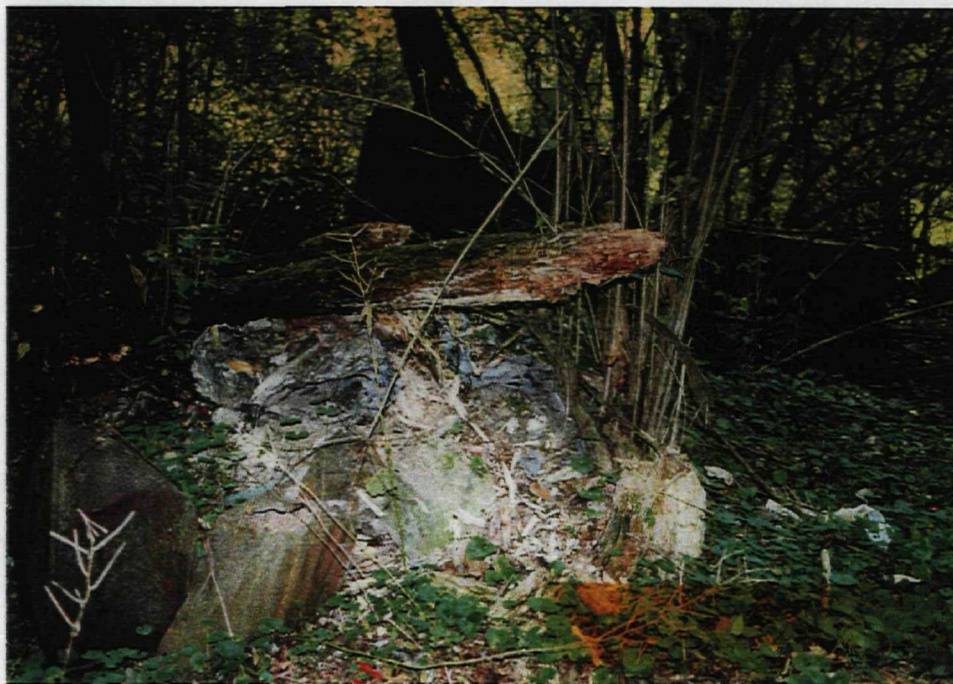
Photograph No. 2
 Orientation: North
 Description: Exposed waste area showing bulk waste material

Location: Exposed waste area
 Date: July 28, 1994

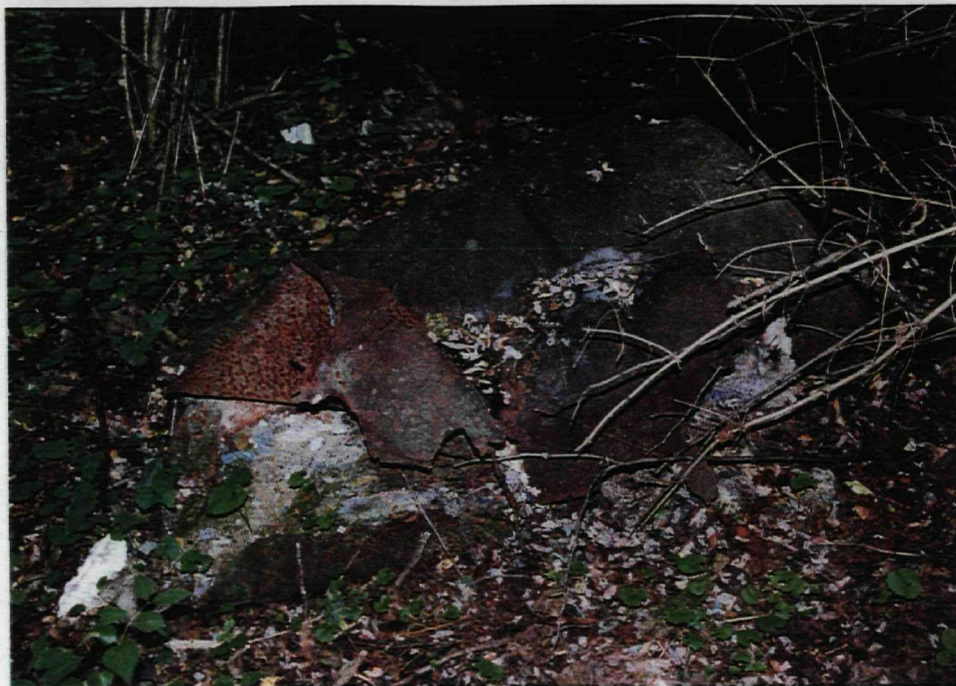
Photograph No. 3

Description: Exposed waste area showing rusted drum with solid waste inside

Location: Exposed waste area

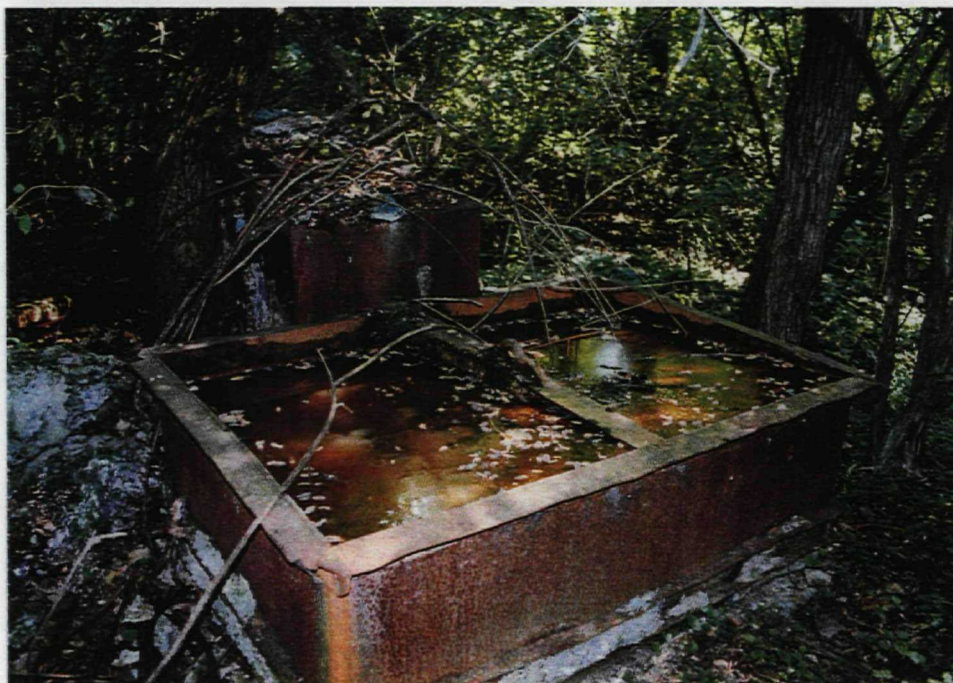
Photograph No. 4

Location: Exposed waste area

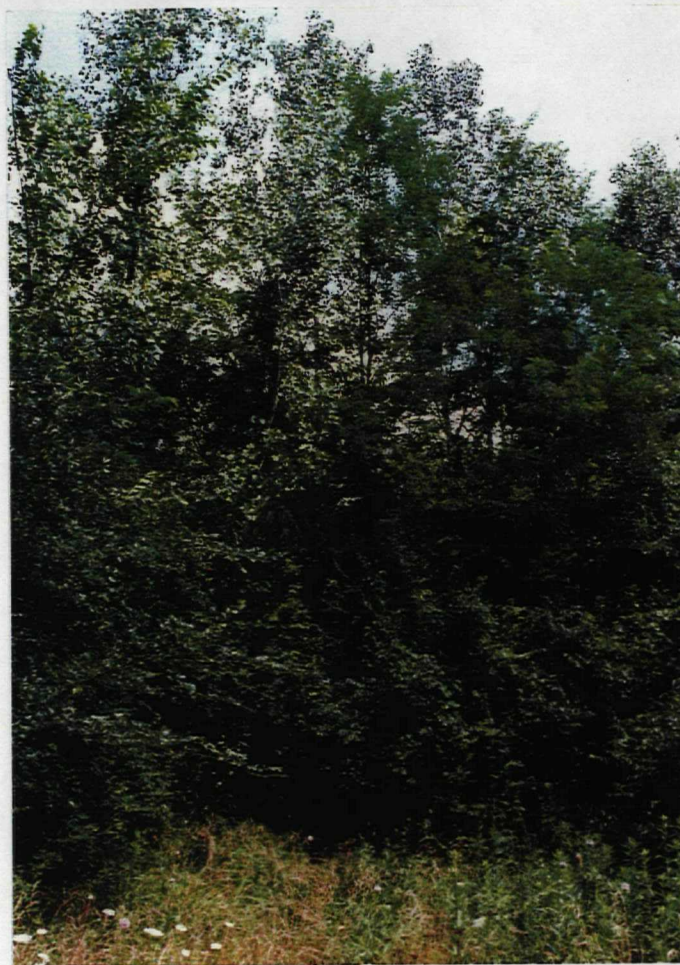
Photograph No. 5

Location: South of site

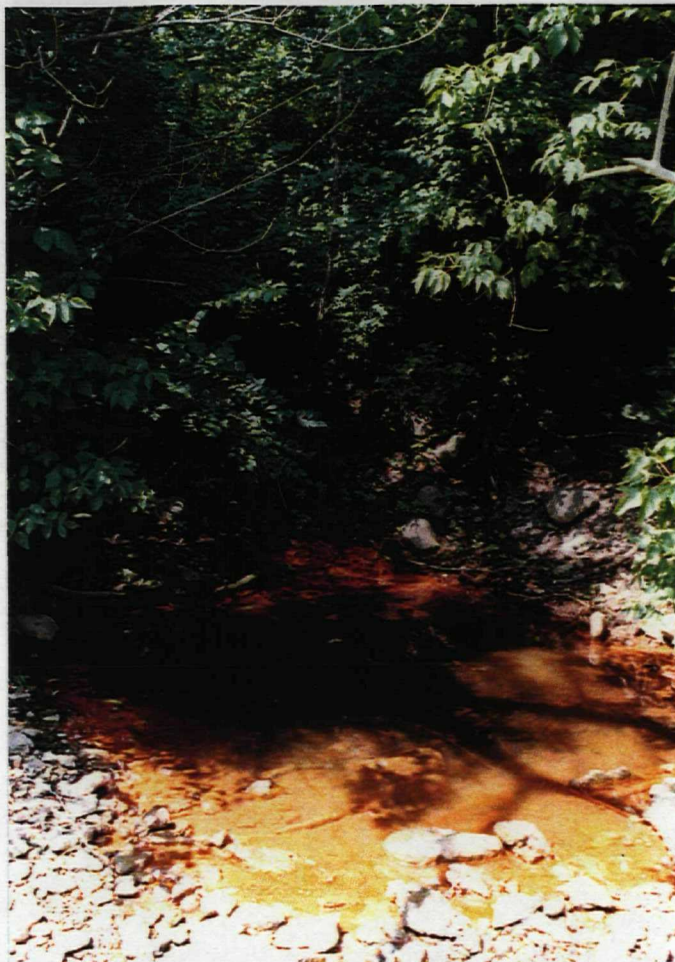
Photograph No. 6
Orientation: Northwest
Description: Drainage pipe near the Scioto River

Location: Bank of Scioto River
Date: July 28, 1994

During PRC's 1994 site reconnaissance, a drainage pipe near the site was observed discharging into the Scioto River (see Photographs No. 6 and 7). The approximate location of this drainage pipe is about 1,000 feet southeast of the site and is shown in Figure 2. The material discharging from the pipe appeared to be water with a high iron content. The probable high iron content was indicated by the orange stains on nearby rocks. No oily sheen was observed on the water discharging from the pipe. However, a slight film was noticed on the Scioto River near where the water entered the river.

It is not known where the water discharging from the pipe originates. A small depression exists directly inland from the discharge point, and the pipe may be an outlet for a system that drains the depression. Nevertheless, because of the close proximity of the discharge point to the MCQD site, it is possible that hazardous substances associated with the MCQD site may be released to the Scioto River via this pipe.

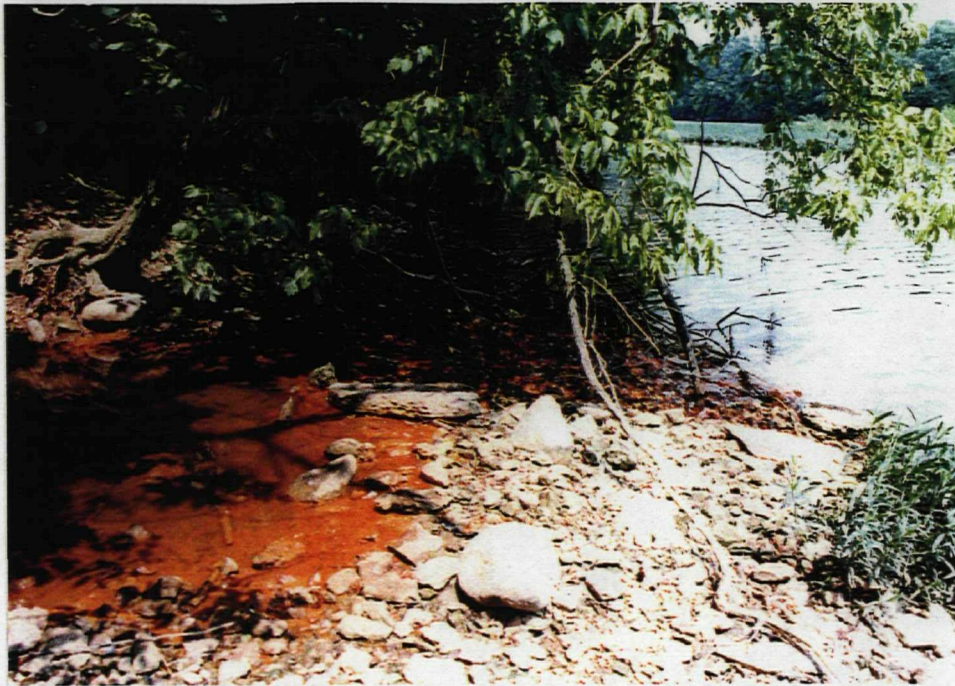
Photograph No. 7

Location: Bank of Scioto River
